Voice of America Mall Target Project: A Steel Push Pier Underpinning Case Study

by Howard Perko, Bill Bonekemper, Dave Jacob and Brian Dwyer
Magnum Piering, Inc., West Chester, Ohio

March 18, 2003

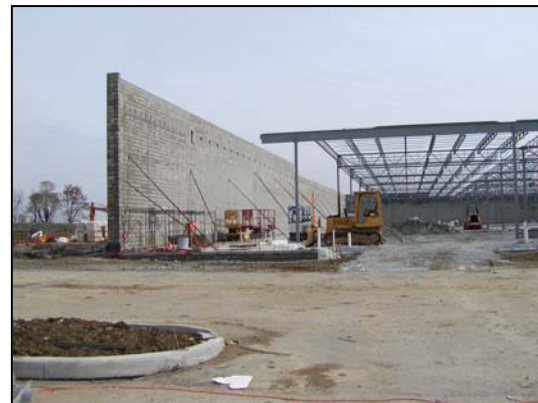
The first wall that the owner, the construction manager, and Dwyer's Dave Jacob visited was the north wall – the wall with the most severe problem. A considerable crack in the interior concrete slab was immediately apparent, and it measured approximately 1/2" to 5/8" wide at its worst point. The crack ran adjacent to the wall for approximately 200 feet and ranged in distance from 3 to 4 feet from the wall's base. The two men quickly pointed to some hand written measurements marked at eye level on the wall about every 20 feet. As they explained to Dave, these markings represented the distance the north wall had rolled outward (to the north) at the top of its 27 foot height as measured by the steel contractor on October 10th. The measurements ranged from a minimum of 1/8", close to both the west and east corners of the wall, to a maximum of 2-3/4", near the center of the wall's 310-foot total length.

Due to the close proximity of the adjacent property line, the design was changed and instead the first approximately 250 feet of the wall's footing was shifted inward and constructed flush with the exterior alignment of the CMU block wall. This change in the foundation design, in conjunction with heavy amounts of rain at the site for several days, were deemed, by Elford's structural engineers and the contracted geotechnical firm for the project, to be the sources of the failure.

Fig. 1 North Wall of Target Store Under Construction

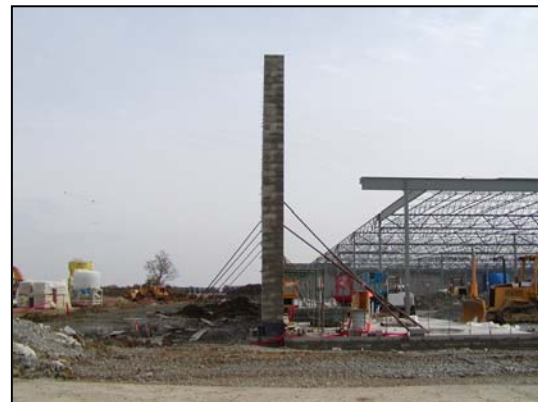
eastern district, and the two men explained to Dave that there was a serious foundation failure on the north and south walls of this 120,000 sq. foot store. The problem was described to Dave as critical because all steel roofing and steel structural work had been shut down. After this brief introductory meeting, the three men went to view the problems with the walls. Photographs of the site before repair are shown in Figs. 1 and 2. As can be seen in the figures, the store was in the early stages of construction. Concrete masonry unit (CMU) block walls had been constructed and were temporarily braced for wind

Fig. 2 North Wall of Target Store Showing Lateral Bracing

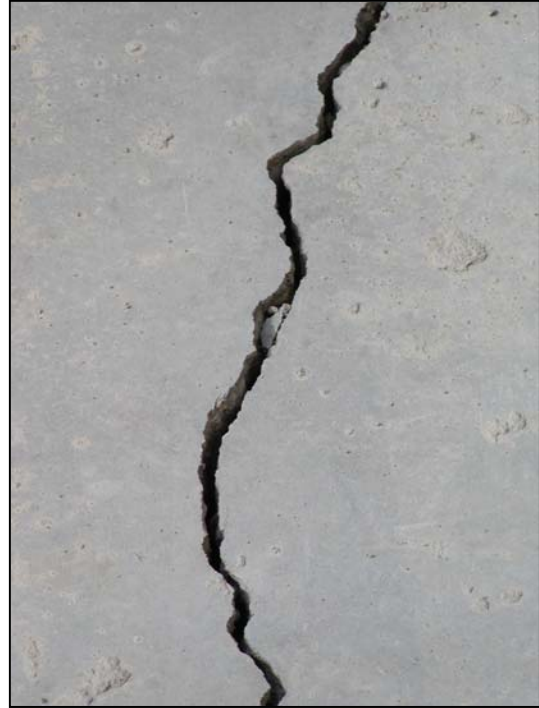
Fig. 4 Close-up View of Example Floor Slab Crack

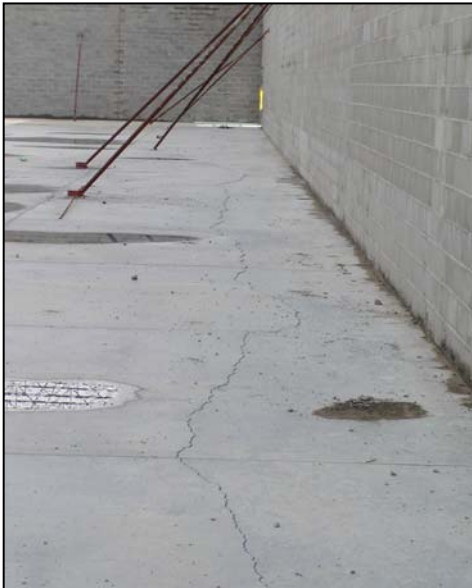
When the three men finished discussing the conditions at the north wall, they quickly went to examine the similar conditions at the structure's south wall. Although the settlement and subsequent outward roll of the south wall was not as severe as with the north wall, the top of the south wall had rolled outward (south) 1-7/8" inches near the center of the wall's 260 foot total length, as recorded by the steel contractor. The concrete slab also had a crack similar to the crack at the base of the north wall. The slab crack is shown in Figs. 3 and 4. A similar foundation design change had been made on this side of the building due to the close proximity of the property boundary. The foundation failure of the south wall was again attributed to the eccentric loading on the spread footing for the first approximately 200 feet of the wall measuring west to east. A photograph of one of the cracks in the CMU block wall is shown in Fig. 5.

Fig. 3 Example Floor Slab Crack Adjacent to South Wall

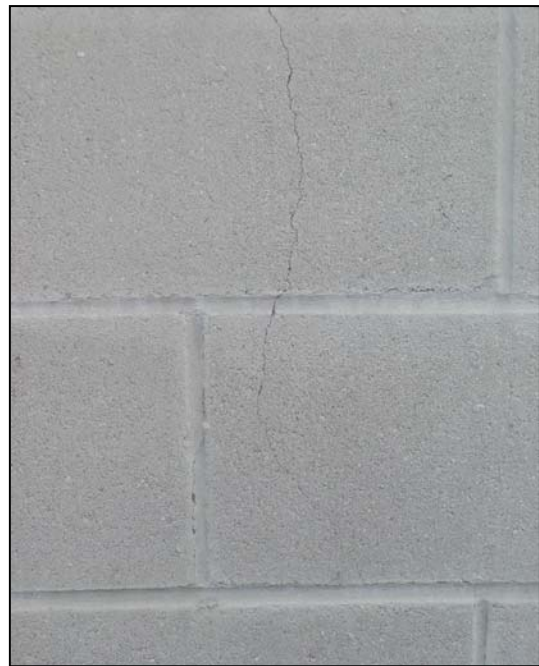
Fig. 5 Example Vertical Crack in South Wall of Target Store

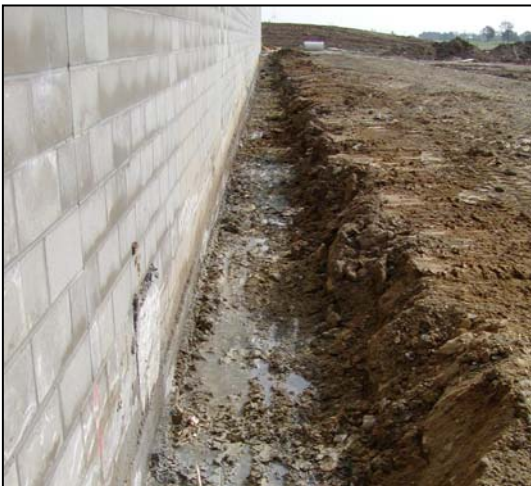
Adjacent property lines to the south and north walls were extremely close. In fact, the store width was only 8 inches smaller than the lot width. This condition necessitated that the foundation had to be virtually flush with the block wall as shown in Fig. 8.

Fig. 8 As-Built Spread Footing Shown Nearly Flush with Exterior Wall

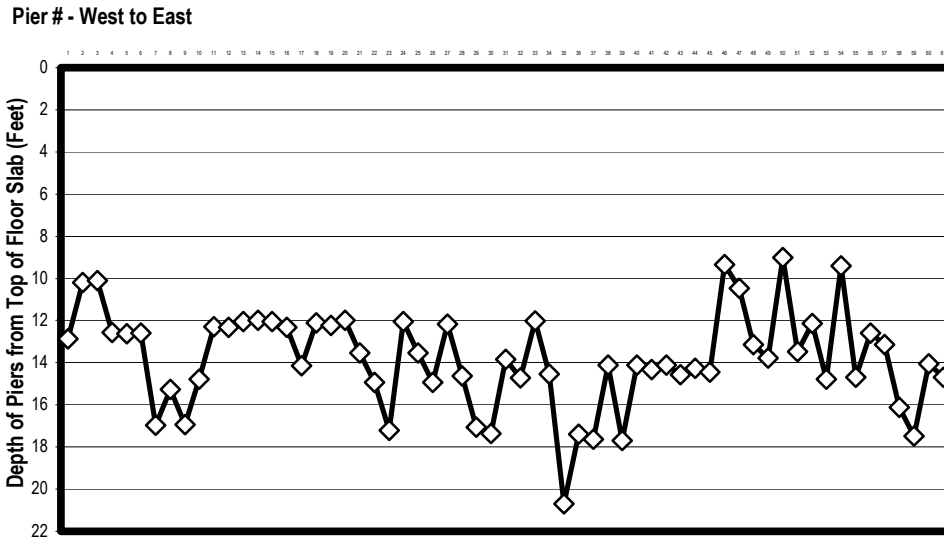
As can be seen in the figures, the final depth of the piers along the North wall varied from 10 to 20 feet below the top of slab and along the South wall from 15 to 19 feet. In either case, a discernable profile is evident. The reason for larger variation in pier depth on the North side of the site is unknown. However, the depth of the piers was generally consistent with the depth and variability of bedrock described in the geotechnical engineer's report for the project site. It was concluded that all piers are likely supported on or within the bedrock.

Fig. 14 Final Pier Depths Along North Wall

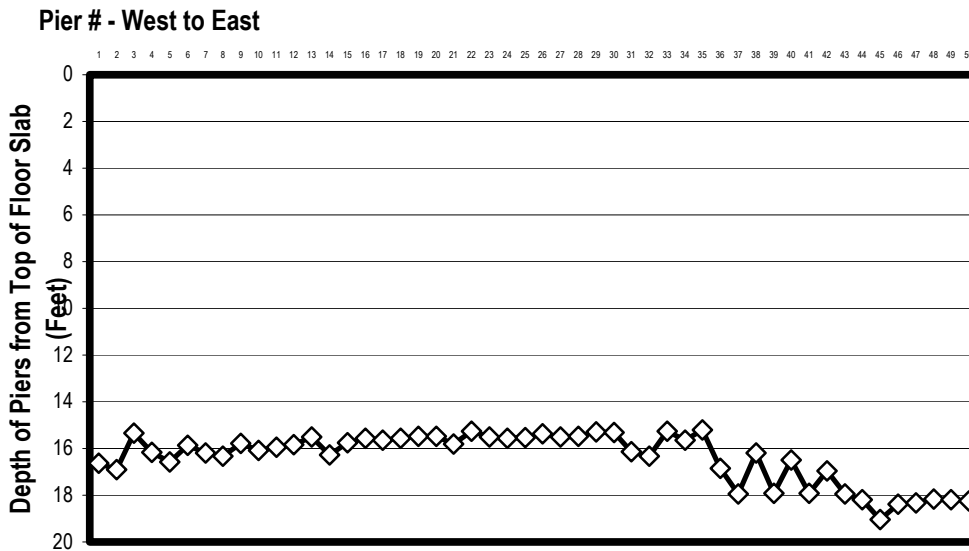
Fig. 15 Final Pier Depths Along South Wall

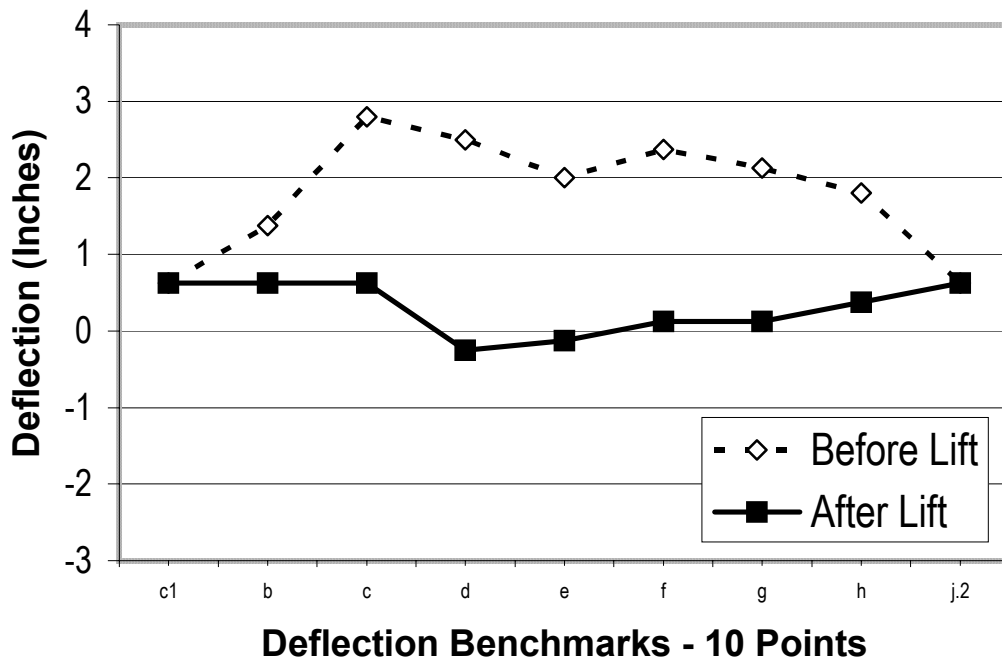
Fig. 16 Initial and Final North Wall Top Location

Both walls were successfully relocated. Initial and final top of wall locations with respect to plumb are shown in Figs. 16 and 17. The North and South walls were restored to within ½ inch of plumb, except for the Eastern portion of the South wall. The reason for this discrepancy is that the wall was not constructed perfectly straight. It was identified during this phase that the South wall had started to settle during masonry construction, and the block mason had to adjust the course of the wall. Afterward, the wall continued to move and eventually ended in the position where Dwyer was called to the site. The wall could not be improved beyond that shown unless it was reconstructed. It was deemed that the lift was acceptable and the underpinning project was completed.

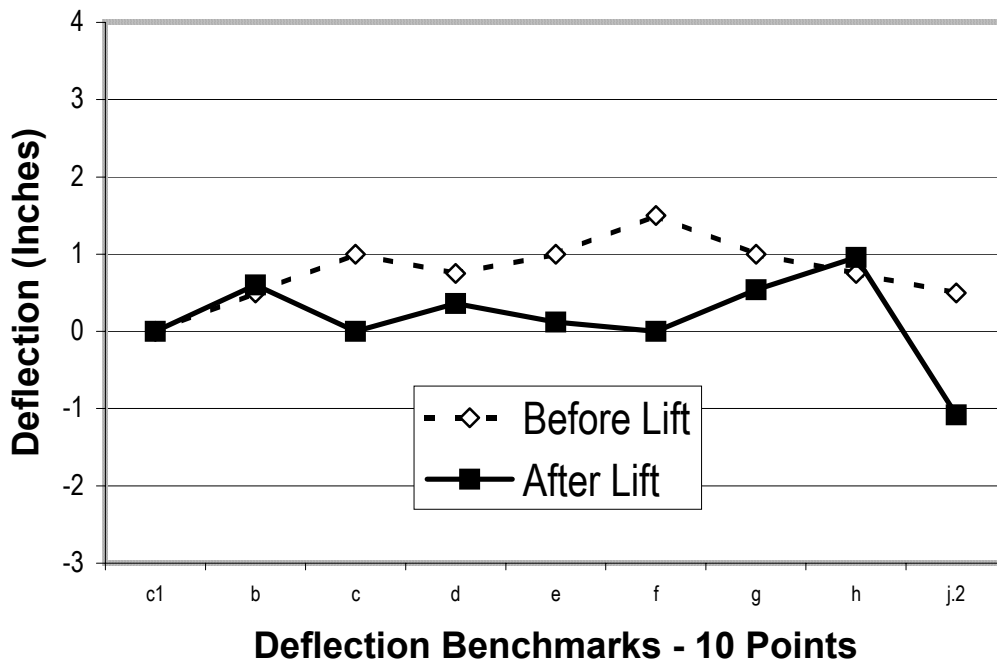
Fig. 17 Initial and Final South Wall Top Location
